# Manhole Inspection Summary

## Manhole # S21EE1019MH

**Location** Address: **I-83**

Cross Street: **41ST ST**

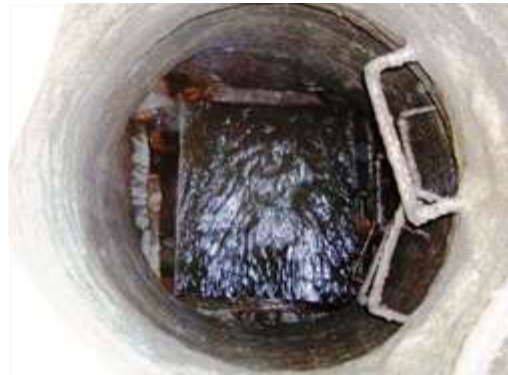
Top View

Corroded steps.

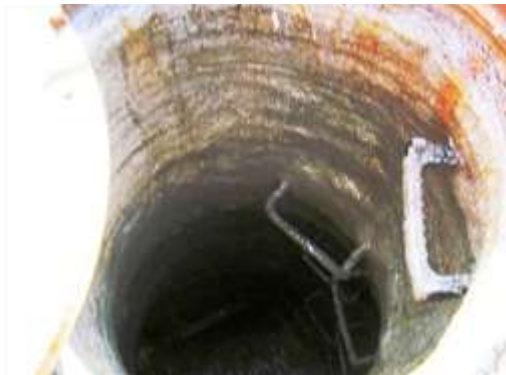
Defect

Adjustment, Corbel and Barrel infiltration - other side.

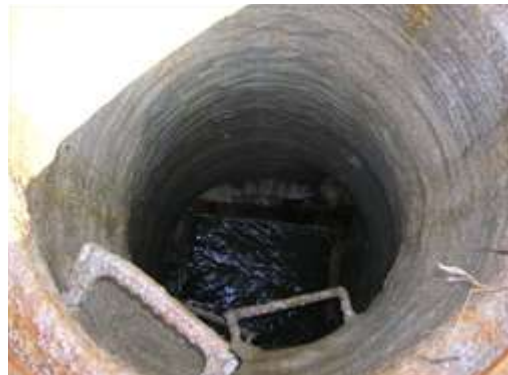
Defect

Adjustment and Barrel infiltration.

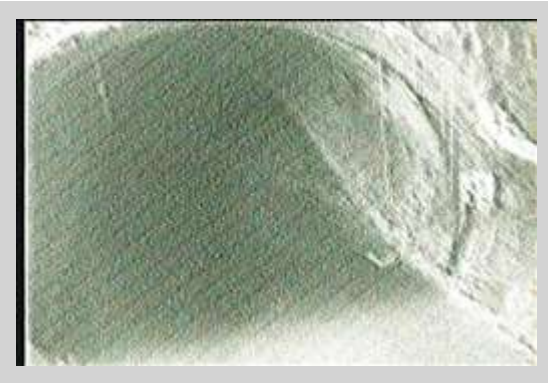
### 60 in. Circular Gravity Sewer Pipe Out @ 12 O'Clock

Infiltration: **Evidence** Pipe Seal Cond: **Roots**

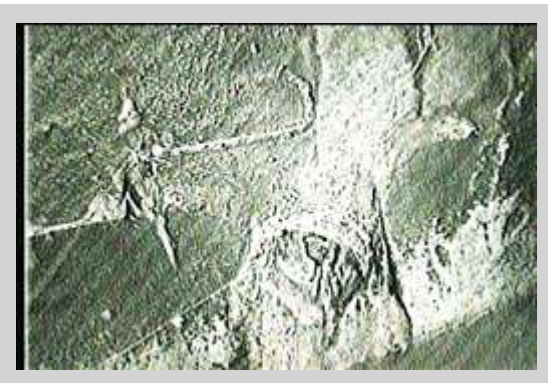
### 8 in. Circular Gravity Sewer Pipe In @ 4 O'Clock

Evidence of surcharge.

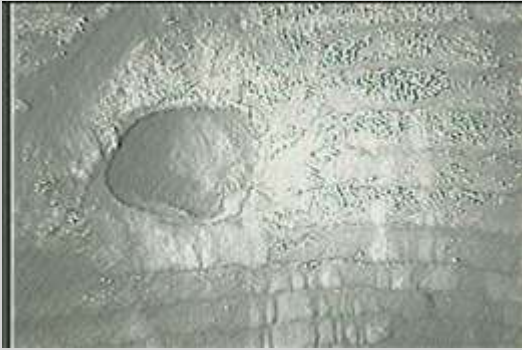
### 8 in. Circular Gravity Sewer

Comments **Bolted Lid - missing bolts. There is heavy clear flow from the I4 pipe. The I5 pipe picture shows active infiltration.**

Active infiltration.

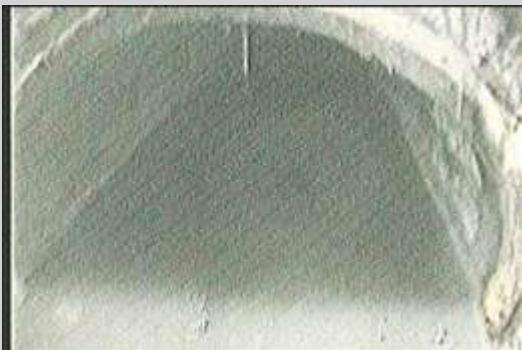
### 60 in. Circular Gravity Sewer

Infiltration: **Evidence** Pipe Seal Cond: **Unknown**

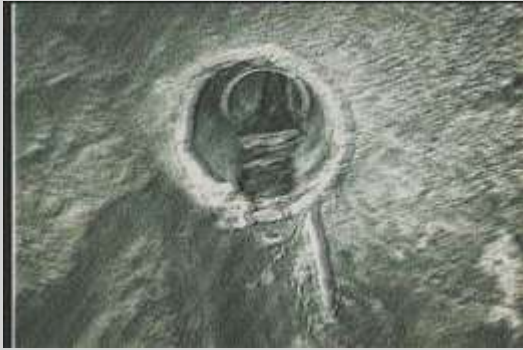
Pipe In @ 11 O'Clock

Infiltration: **Evidence**

Pipe Seal Cond: **Roots**
